DURA CLUTCH INSTALLATION
15-510 DCG1-RANGER900-B

PART #: 15-510

MODEL: DCG1-RANGER900-B

DESCRIPTION: MY15 RANGER 900XP, MY16,17 RANGER 900 ALL MODELS

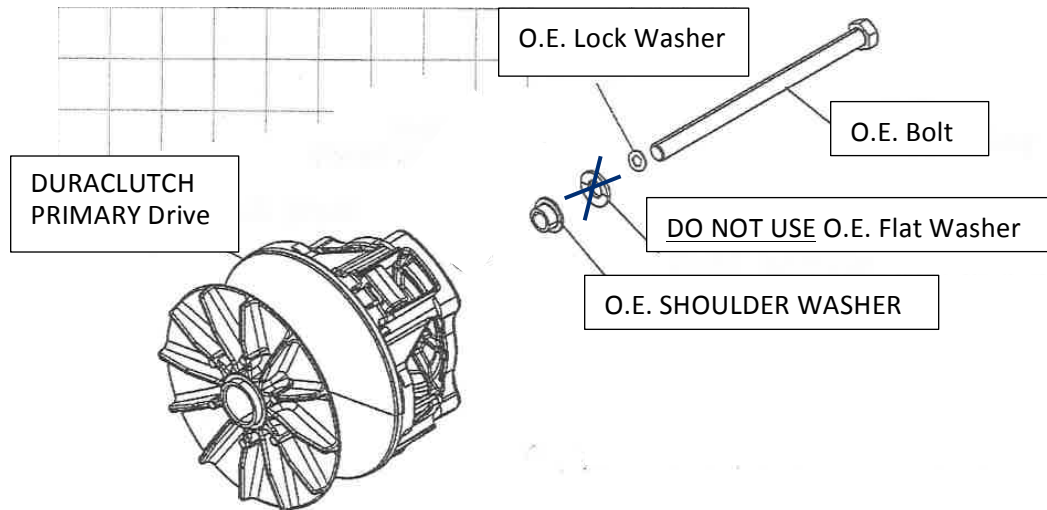
1. Remove the Secondary clutch.
2. Install DURACLUTCH Secondary. If there is a snap ring on the transmission shaft behind the secondary remove it. Tighten bolt to 48 ft-lbf.
3. Remove Primary clutch bolt. Remove the Primary clutch with a puller (SVI 25-147). Greasing the end of the puller slightly will aid in removal. Do not get grease on any clutch components.
4. Clean the engine tapered shaft and primary clutch bore with alcohol or degreaser. Do not lubricate.
5. Slip the belt into the DURACLUTCH Primary and over the Secondary.
6. Install DURACLUTCH Primary with shoulder washer as shown. DO NOT USE the O.E. flat washer. It may interfere with the Primary cover. Tighten bolt to 60 ft-lbf.

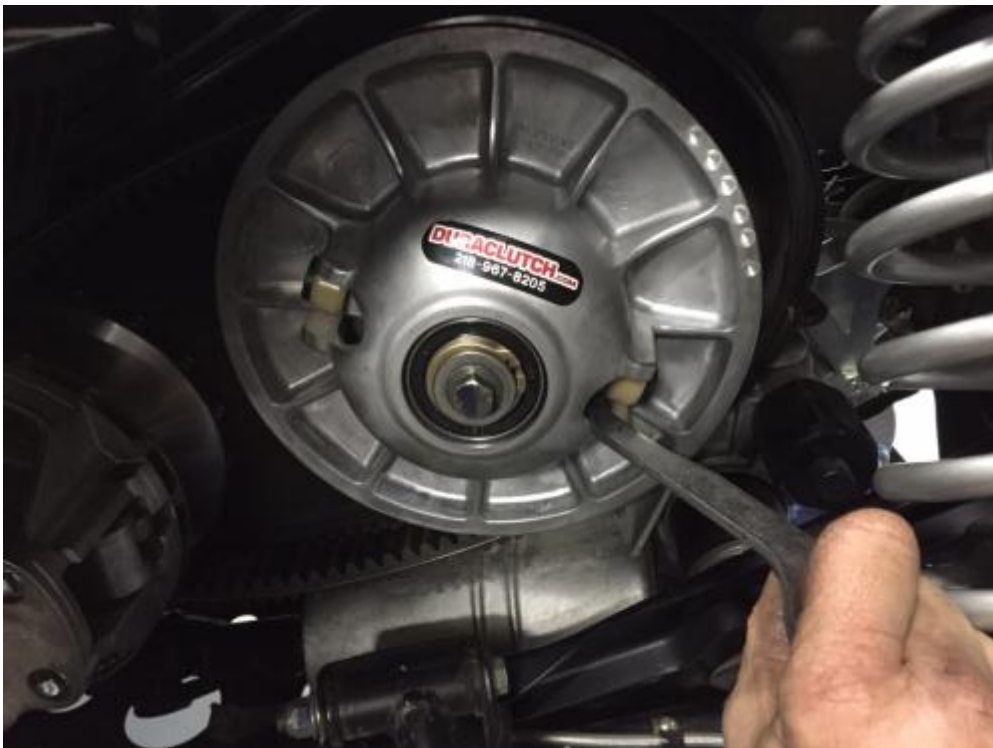
7. Install the Belt as follows if the Primary and Secondary are already installed. Place Belt in the Primary and open the Secondary sheaves with the Belt Installation Tool provided (see photo). Roll belt into the Secondary sheaves.

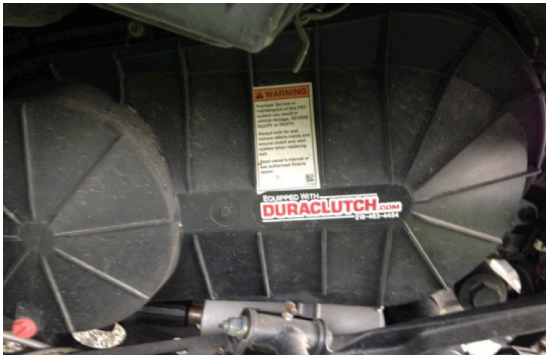
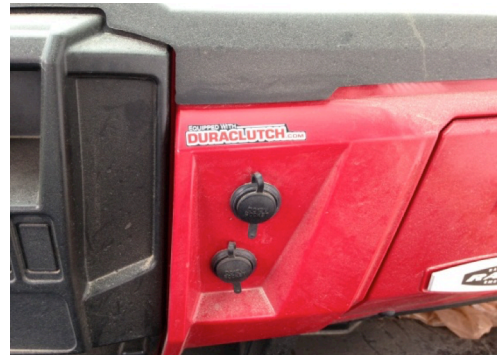
DECALS

10. Apply two decals as shown – one on the clutch housing and one on the dash. Clean surface with alcohol or similar non-harsh solvent. Decal application is important to alert service technicians that the standard Polaris clutches have been replaced.
